Reducing the damage caused by freight train derailments

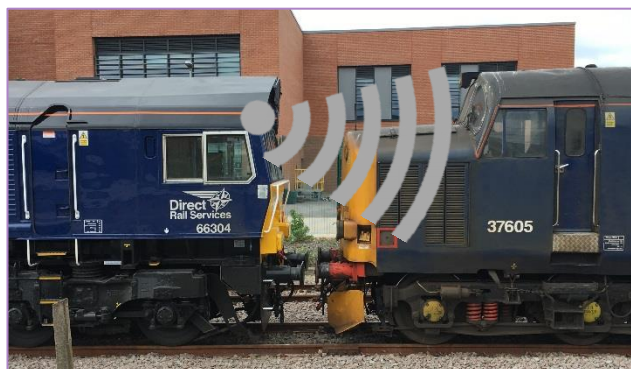
Figure 1 Positioning of FFCCTV camera

The CCTV cameras would be set to view down each side of the train. The use of two cameras would prevent blind spots caused by the curvature of the line and would assist in the determination of the derailment through the visual alignment of the sides of the vehicles.

The use of forward facing CCTV (FFCCTV) has become standard on passenger trains over recent years and has been demonstrated as most useful in determining incidents, particularly involving trespass and track workers. Our solution would be to fit all freight locomotives with FFCCTV in the form of two cameras at each end, one on each side of the cab at cant rail level. These would be fitted with infrared capability to enable continuous vision even in tunnels and during the hours of darkness.

The FFCCTV at both ends of the locomotive would record the usual visual output for the purposes of reactive post-incident review. The FFCCTV at the rear of the locomotive would be actively monitoring the state of the train and would alert on unusual activity via a resettable indicator on the driver's desk. A future development may be the displaying of the CCTV image on the driver's console following an alarm to enable the driver to review the severity of the situation.
